OREX BRAKE DRUM TECHNICAL MAINTENANCE BULLETIN

In order to maximize the service life of your OREX brake drum, proper installation, periodic inspection, and maintenance procedures must be followed. The information contained in this manual will help in establishing a brake drum maintenance program that will help you spot problems and take the necessary corrective measures to restore balanced braking and ensure safe, reliable brake system performance.

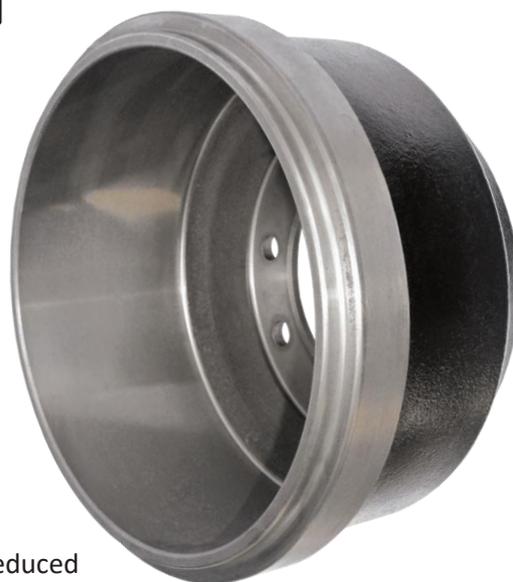
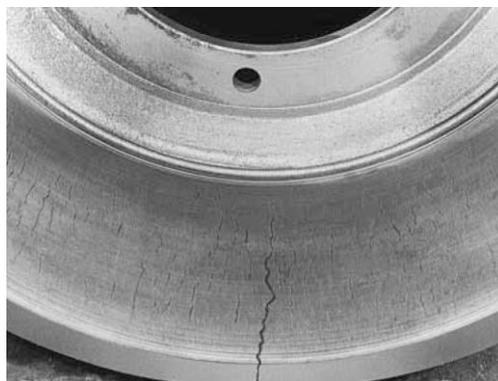
CRACKED DRUMS

Upon inspecting the drum, a crack extending through the entire wall is found. This condition is caused by excessive heating and cooling of the brake drum during operation. If this condition is found, the drum **MUST** be replaced immediately. Repeated cracking of brake drums may indicate that the brake system and/or the brake drums are inadequate for the particular application. This condition may also indicate driver abuse, particularly if the drums, lining, and brake system are correctly rated for the vehicle and the application. If this problem occurs, the brake system should be checked for proper brake system balance and proper brake lining friction ratings as recommended by the OEM. If this problem occurs on a new drum, cause may be from mishandling.

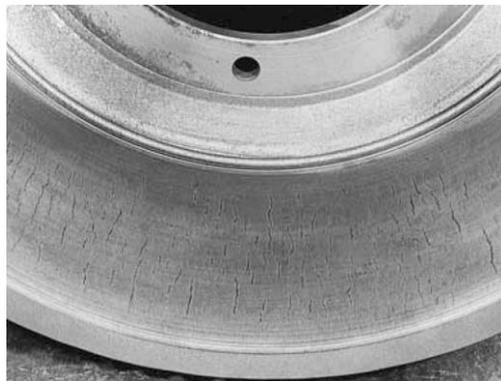
HEAT-CHECKING

Heat-checking is the appearance of numerous short, fine, hairline cracks on the braking surface of the drum. Heat-checking is a normal condition found on brake drums and is caused by the constant heating and cooling of the braking surface, which occurs as the brakes are applied during normal operation of the vehicle. Heat-checks will frequently wear away and form as a result of the normal braking process however, heat-checks can progress over time into cracks in the braking surface depending on such factors as lining wear rate, brake system balance, and how hard the brakes are used. Normal heat-checking does not impair braking performance; however, it is advisable to make sure, that deep cracks have not developed. Replace the brake drum if any of the following conditions are found: heat checks, one or more that extend completely across the brake surface. Heat check cracks that are 1.50mm wide and/or 3mm deep or greater.

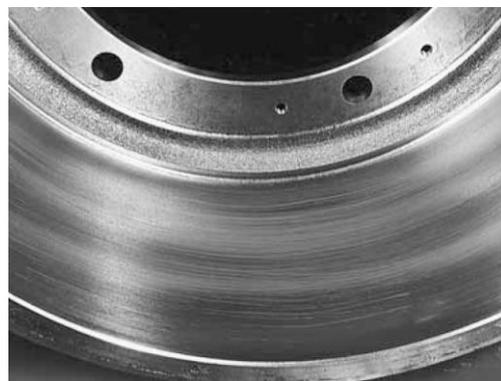
SCORED DRUMS

This problem is indicated by a defined, grooved appearance on the braking surface of the drum and excessive lining wear. If the scoring is severe it is advisable to check the brake system to determine if there are excessive amounts of abrasive material entering and building up on the braking surface of the drum. The system should be checked for lightly dragging brake(s). The linings should also be checked to make sure that they have the correct friction rating.

NOTE: IT IS A RECOMMENDED PROCEDURE TO SAND THE BRAKING SURFACE OF THE DRUM AT THE TIME OF RELINING.

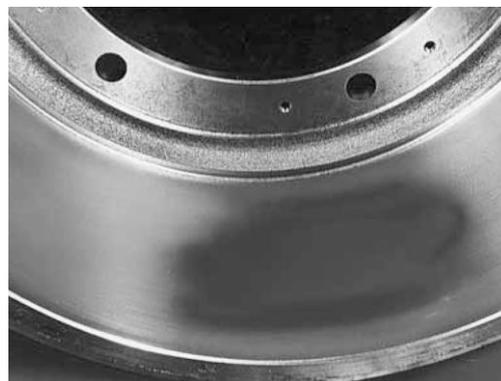
GREASE-STAINED DRUMS

If this condition exists, the brake drum will show discolored spots on the braking surface, with oil and/or grease spattered on the brake assembly. This condition is most likely caused by a faulty lubrication system or improper greasing of the brake cams. To correct the problem, the source of the grease and/or oil must be located and necessary repairs made to eliminate the leak. Remove the entire brake assembly and clean each component thoroughly. If the linings are soaked with oil or grease they must be replaced.

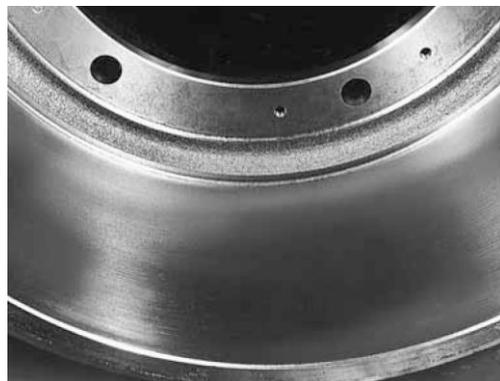
BLUE DRUMS

A drum which shows the signs of bluing has been subjected to extremely high temperatures. This condition may be caused by continued hard stops, by brake system imbalance, or improperly functioning brake hardware components. It is not necessary to resurface or replace the drum as long as it remains within the allowable tolerance for operation. To correct this problem the brake system should be checked for proper balance. The return springs should be checked to determine if they are weak or broken. The brake should be checked for proper adjustment and clearance. If this condition is left unresolved, it can result in the development of a martensite condition or cause the drum to crack.

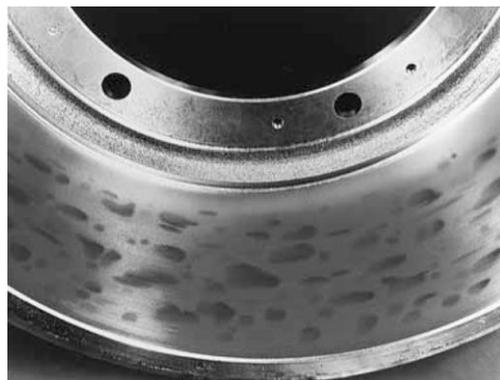
MARTENSITE SPOTTED DRUMS

This problem may be indicated by hard, slightly raised dark coloured spots on the braking surface with uneven wear. This problem may also be indicated by a pulsating ride upon brake application or excessive noise upon braking. This condition indicates that the drum has been subjected to extremely high temperatures caused by an improperly balanced braking system, a dragging brake, or continued severe brake applications. These extremely high temperatures have caused structural changes to occur in the drum material which makes the drum more susceptible to cracking. If this condition exists, the drum must be replaced. The brake linings should be checked for uneven wear and replaced if necessary. After replacing the brake drum, the entire braking system should be checked for proper balance between the tractor and the trailer as well as wheel to wheel (i.e., air distribution, brake adjustment, and power A/L factors).

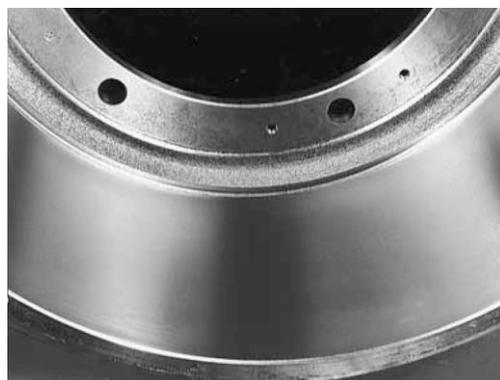
POLISHED DRUMS

A polished drum can be identified by the mirror-like finish on the braking surface. This problem can easily be solved by sanding the braking surface with 80 grit emery cloth. It is also necessary to remove the glaze from the linings at the same time using the 80-grit emery cloth.

The brake system should be checked for lightly dragging brake(s). The lining should also be checked to make sure that they have the correct friction rated brake linings suitable for the environment the vehicle is operating.

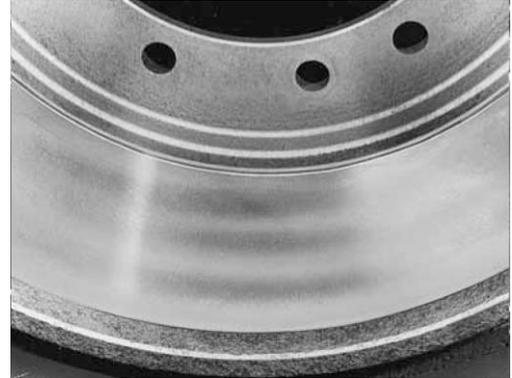
EXCESSIVE WEAR

If excessive wear occurs along the edges of the lining contact area of the braking surface or in areas coinciding with the lining rivet holes, the system should be checked to make sure that there is not an abnormal build-up of abrasive material. The most common cause of this problem is the build-up of abrasive material from either the presence or absence of dust shields depending on the application of the vehicle. If the problem occurs while dust shields are installed, remove the lower dust shield to allow abrasive materials to more readily exit the braking system.

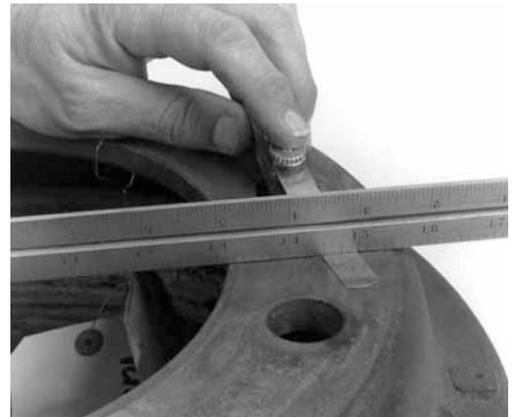
WORN MOUNTING SURFACE

Rounding over of the drum-mounting surface is caused by continued operation with a loose wheel assembly. If this condition is left uncorrected it will cause the wheel bolts to break resulting in wheel-end failure and the loss of the wheel assembly. To check for this condition, use a straight edge and a feeler gage as shown. If the wear exceeds .762mm, the drum must be replaced along with all wheel bolts in the assembly.

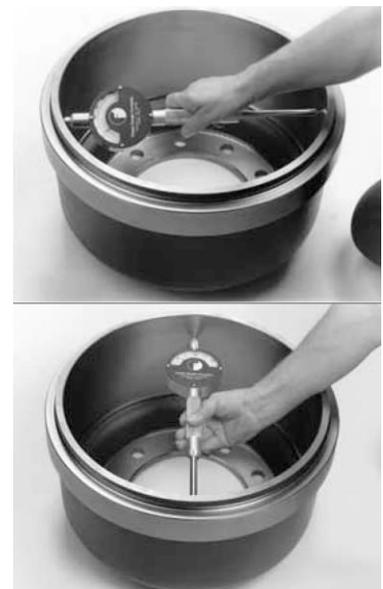
OUT-OF-ROUND DRUMS

This condition exists when the drum diameter shows variations at different points around the braking surface and the brake linings exhibit more wear on one side than the other. This distortion of the drum as a result of excessive heat generated during brake applications or as a result of improper drum storage techniques (see proper drum storage recommendations on page 5 of this manual). Other possible causes for this condition could be the result of dropping the drum on a hard surface during routine wheel-end maintenance. If the diameter of the drums braking surface is within allowable limitations (see note below), the drum can be machined to restore concentricity. If the drum diameter is past the recommended limitations, the drum **MUST** be replaced.

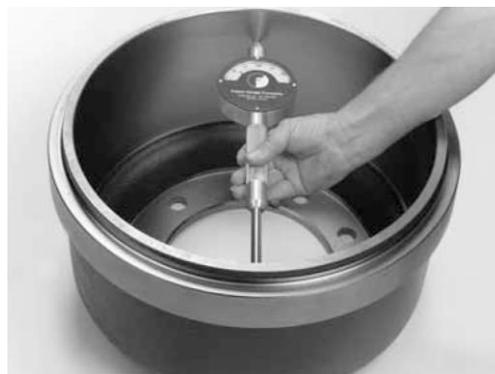
OVERSIZED (WORN) DRUMS

This condition is indicated by either excessive wear at the lip (outer edge of the drum) or improper lining to drum contact during brake application. To check, use a drum gage as shown to measure the diameter of the drum at least 25mm from the lip or outer edge of the braking surface. If the measurements exceed the allowable limitations, the drum **MUST** be replaced and new linings should be installed.

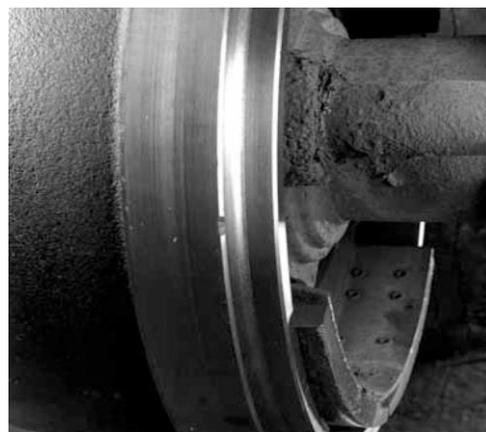
Linings protruding past the braking surface:

This condition can be identified by visually inspecting the brake assembly for evidence of the lining protruding past the outer edge of the braking surface as shown at left. If this condition exists, check the hub application specifications to determine the proper drum for the application and replace the drum and install new linings if the old linings are damaged.

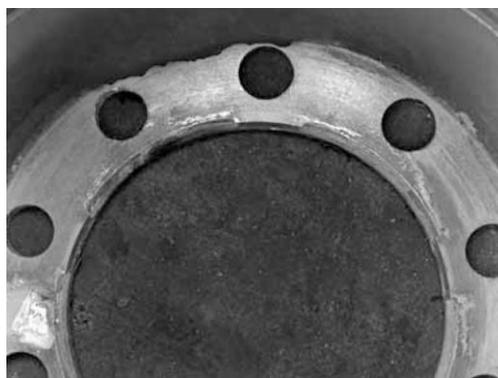
Broken mounting ring:

This problem can be identified by the presence of fractures or cracks around the bolt circle or mounting surface of the drum. This condition is caused by interference between the hub and drum-mounting surface due to improper seating of the drum on the hub pilot during installation or by installing a drum with a mounting ring diameter smaller than the hub pilot diameter. If this condition is present, the drum **MUST** be replaced. Check the application specifications to determine the proper drum for the application before attempting to install a replacement drum.

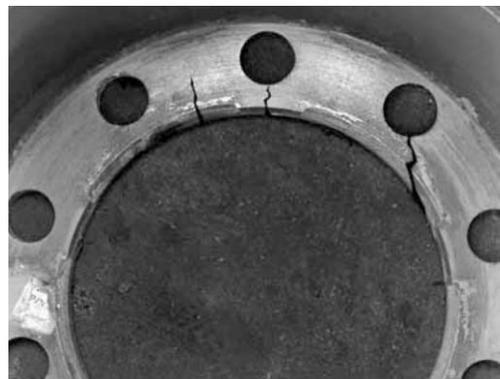
Radial cracking of the bolt holes on the mount surface:

This condition is caused by interference between the hub and drum-mounting surface during installation as a result of using the wrong drum for the application or improperly cleaning the hub piloting surface prior to drum installation. If this condition exists, the drum **MUST** be replaced. Check the application specifications to determine the proper drum for the application before attempting to install a replacement drum. Before attempting to re-install another brake drum, visually inspect the hub-piloting surface and make sure that all dirt and corrosion are properly removed.

Also, take care when installing the drum to make sure that the drum-mounting surface is properly and evenly seated against the hub mounting surface before torquing the wheel nuts during re-assembly.

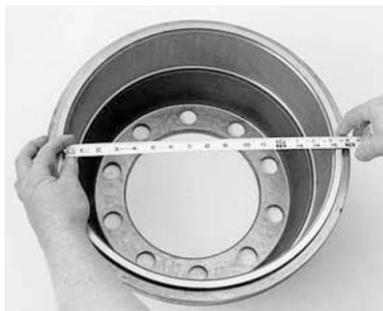
1. Braking surface diameter

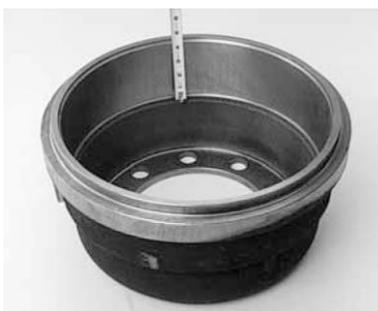
2. Width of braking surface

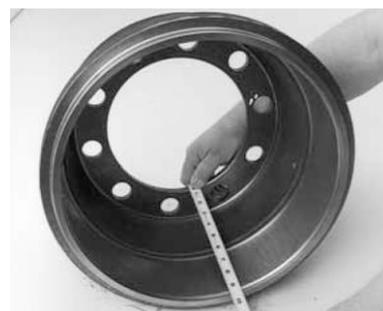
3. Overall depth of the drum

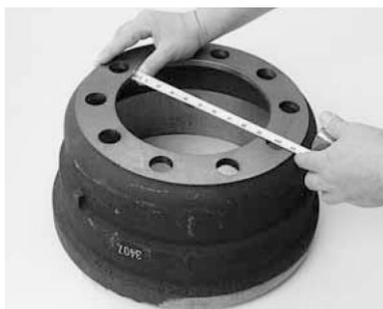
4. Pilot diameter

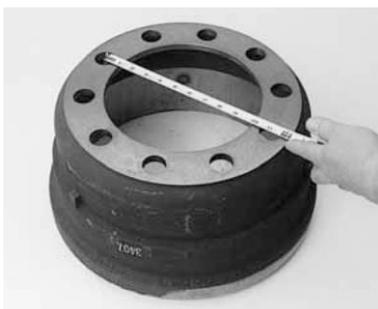
5. Bolt circle diameter

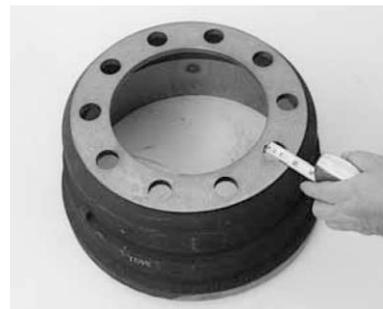
6. #, size & location of bolt holes

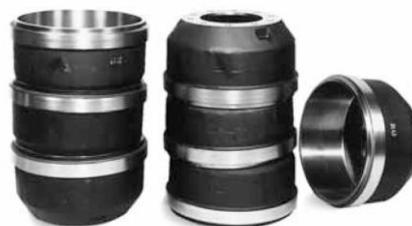
FIG 2

Storing brake drums by “nesting” one drum on another as shown in Figure 2, will result in damage to the drums. Storing drums in any of these ways will cause an out-of-round condition to occur which will require machining to restore concentricity before installation.

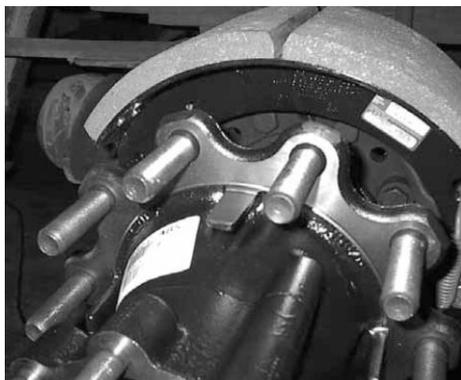
1. Position the hub pilots to be in the 12 o'clock location as shown. **Note: It is very important to make sure that the pilots are clean and free from rust or any other foreign material.**

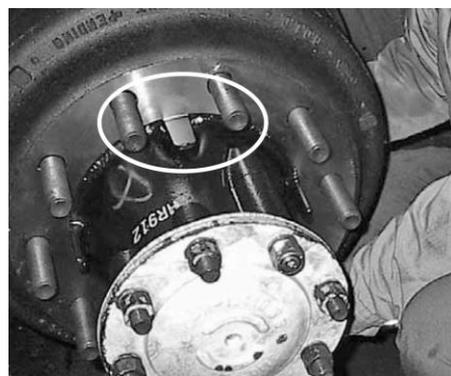
2. Making sure that the drum is mounted onto the drum pilot and the drum flange is flush against the hub flange, hold in on the bottom of the drum and adjust the brake lining until the lining touches the drum. This will hold the drum in place until the wheels are mounted.

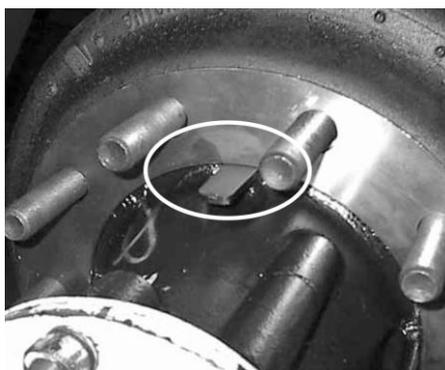
3. Proceed with mounting the wheels and torque to proper specifications. **Do not forget to properly adjust the brakes.**

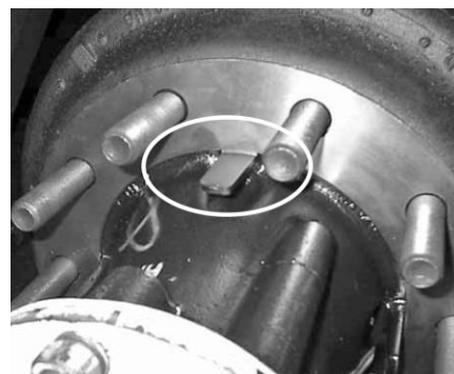
4. The picture on the left shows a drum that has slipped off the drum pilot, see the figure below for proper mounting.

5. The picture on the right shows a drum properly mounted onto the drum pilot.

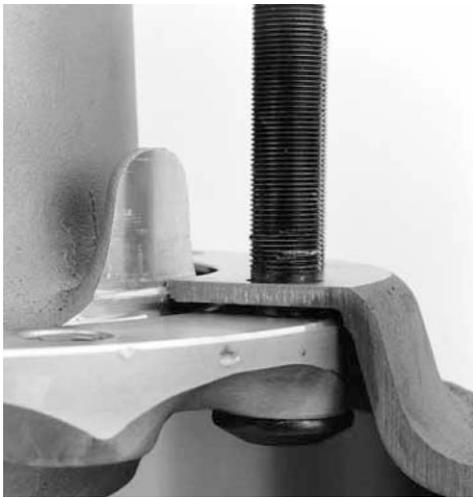
FIG 6

Figure 6 - Improper installation, drum is cocked and not properly seated on the drum pilot of the hub. Unlike traditional cast iron hubs, the surface on the drum pilot of an aluminum hub is susceptible to damage if the drum is not properly seated during the installation process. If the drum is improperly installed and allowed to rest on the wheel pilot, the drum pilot surface will be damaged when the assembly is torqued down. This will not allow the drum to properly seat, resulting in damage to the hub and may also result in a dragging brake condition. (See Figures 6 & 7 below)
